HISTORIC STRUCTURE REPORT

Architectural Data Section

LINDENWALD

MARTIN VAN BUREN NATIONAL HISTORIC SITE

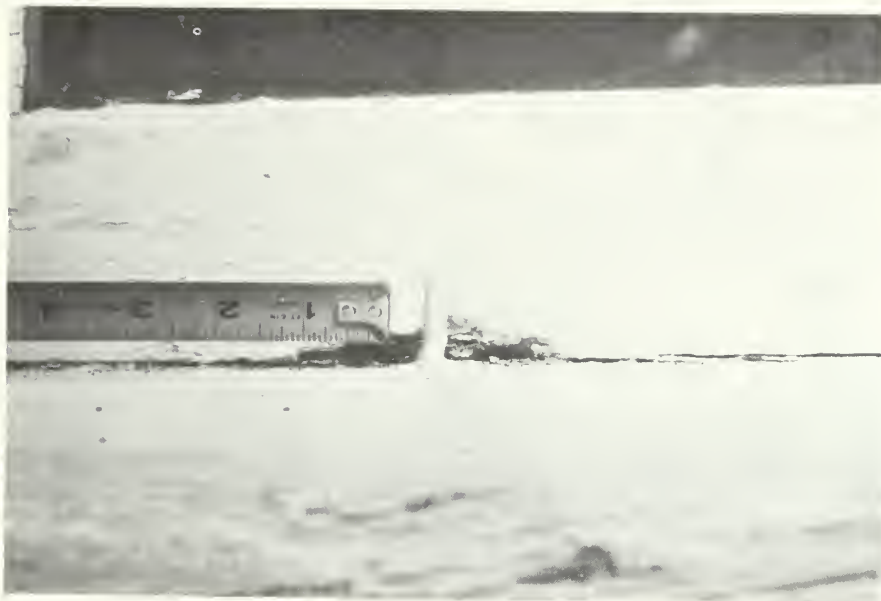
IP138, N033-17. Fastener for exterior shutter blinds.

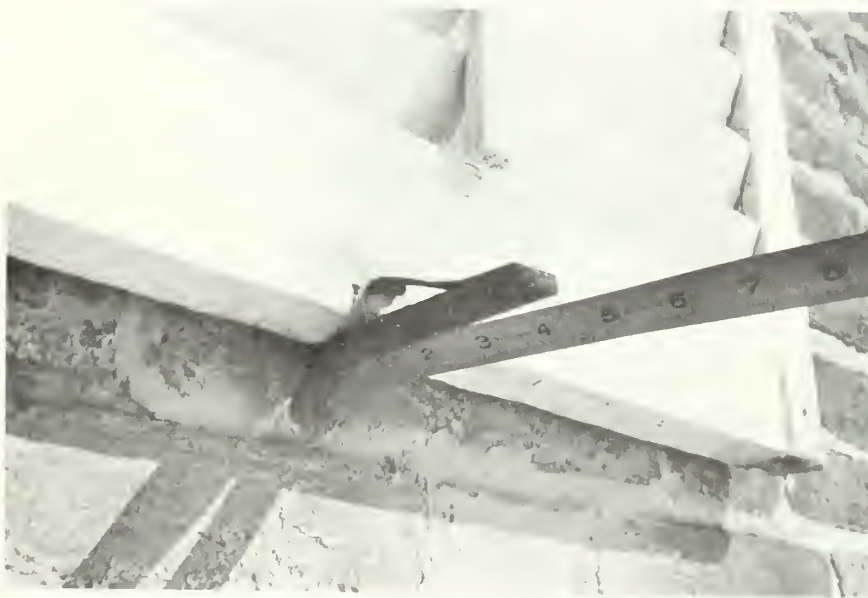
IP139, N033-19. Post for above fastener.

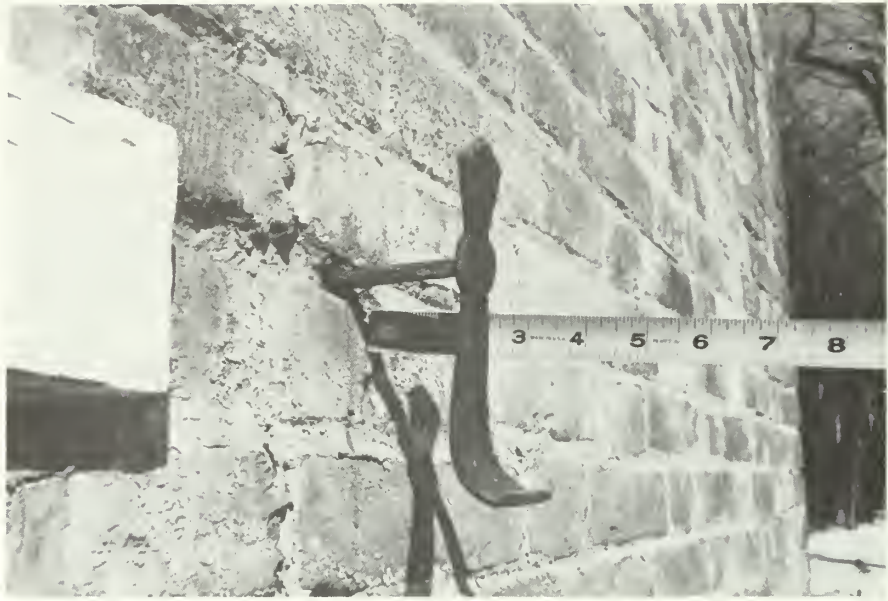
IP140, N033-18. Spring-type shutter holdback.

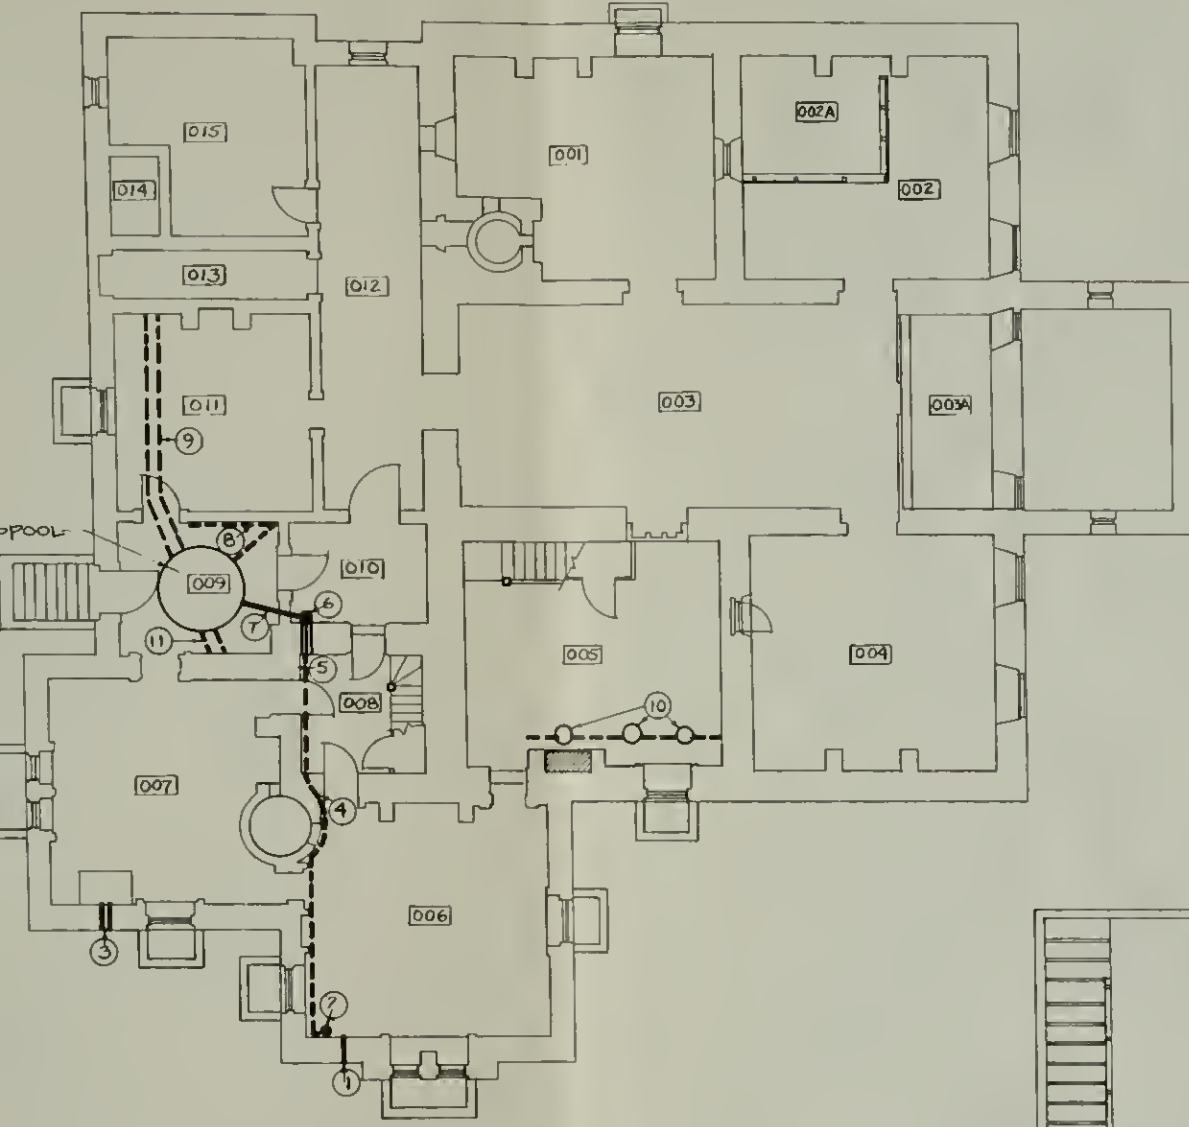
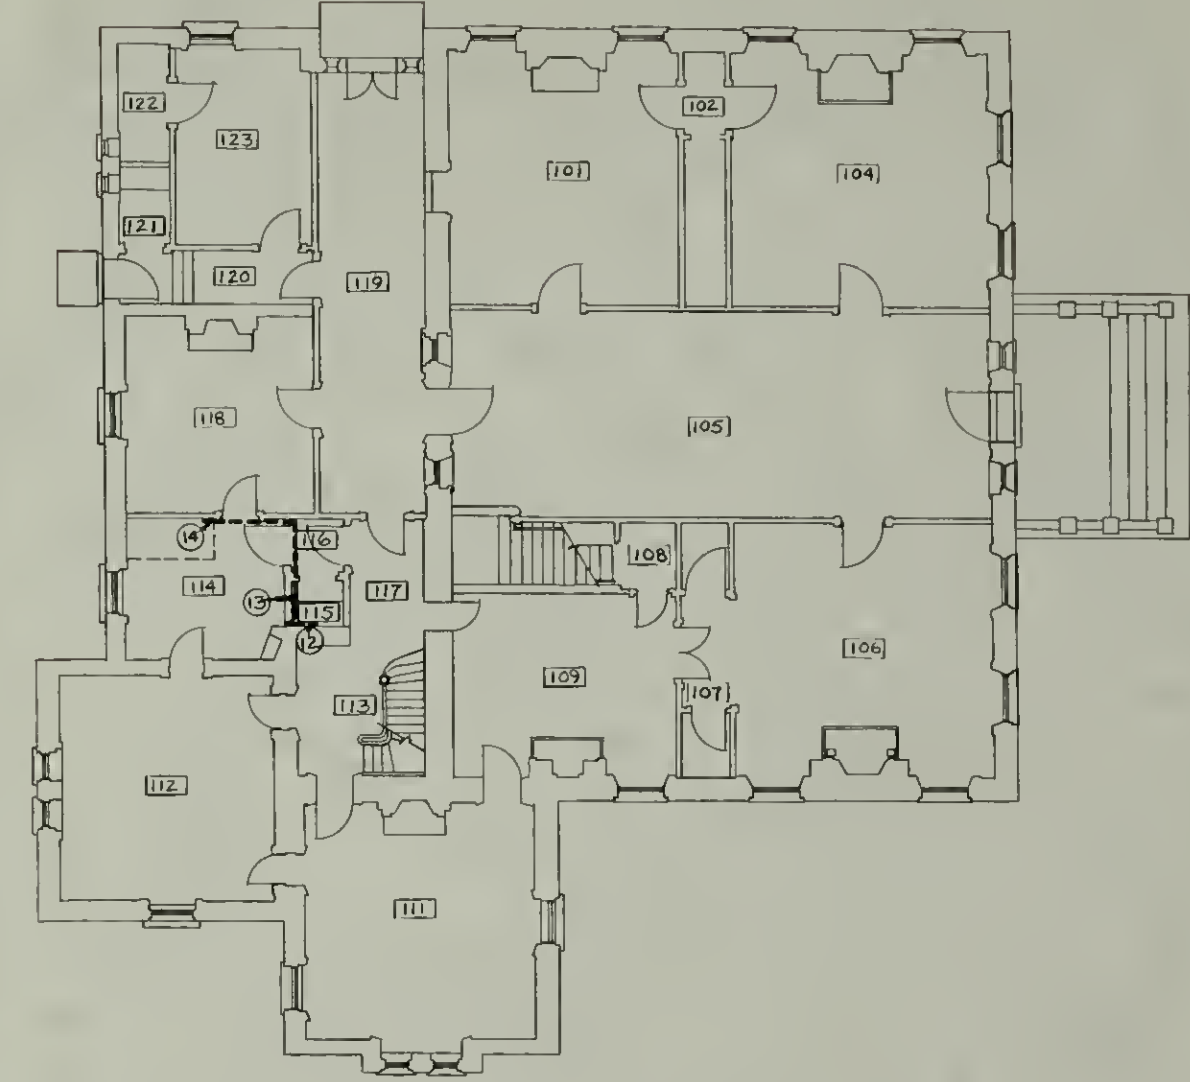
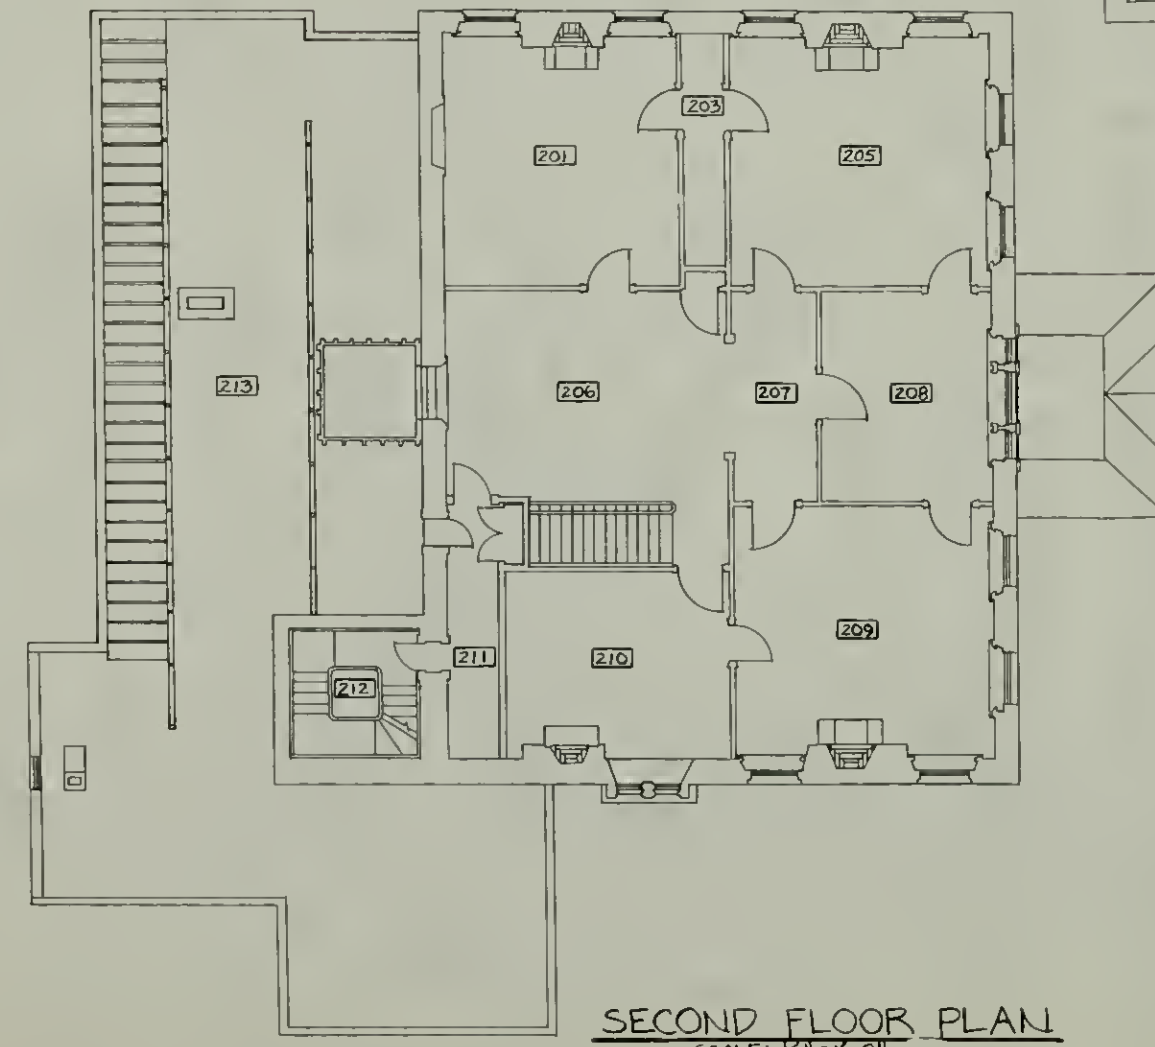
- ⑫ THREE (3) PIPES FROM BASEMENT THAT RUN INTO WATER TANK
- ⑬ SUPPLY PIPE FROM WATER TANK TO SINK (PIPE STILL IN PLACE)
- ⑭ SUPPLY PIPE FROM WATER TANK TO BATHTUB. THIS PIPE RUNS OUT OF THE LOWER WEST SIDE OF THE WATER TANK. IT HAS BEEN CUT OFF PIPE CLIPS AT HOLE IN THE WALL BETWEEN ROOMS 114 AND 116, AND A PAINT ANALYSIS INDICATES THE ROUTE OF THE PIPE.

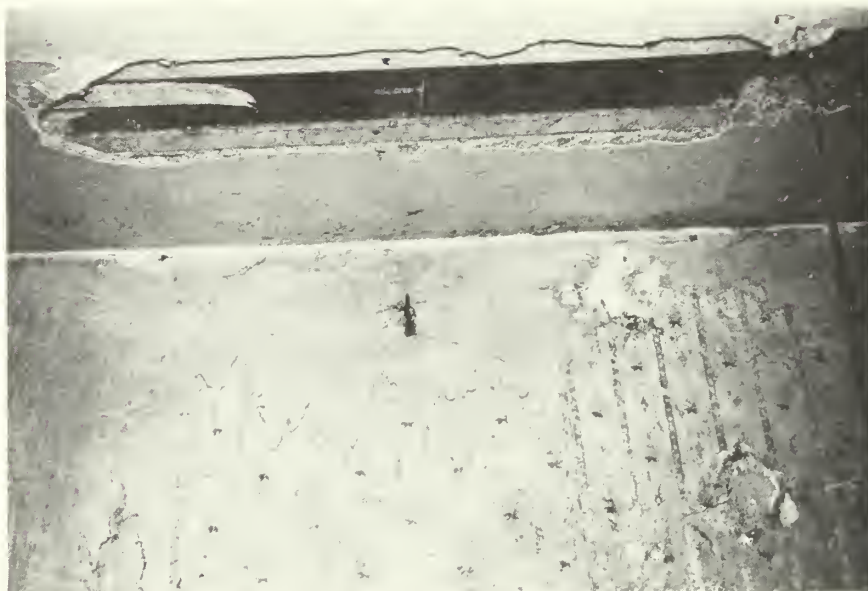
Probably machine--paper
is too badly deteriorated
to positively identify

Comments: This wallpaper hangs in the servants' dining room. It was the only wallpaper found in the basement. The moisture of the basement has caused the paper to deteriorate significantly so that it crumbles when an attempt is made to remove it from the walls.

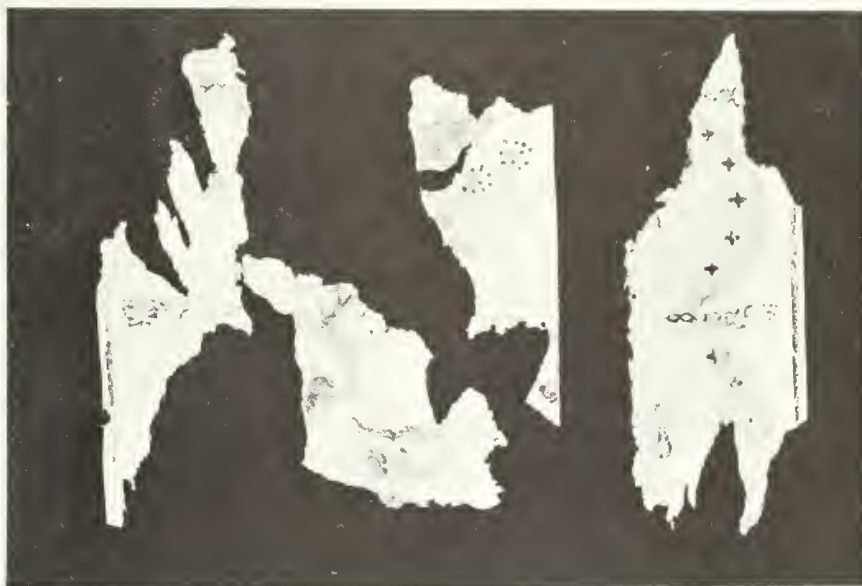
Sample No: MAVA 01 WP004
Location: Room 106
Substrate: Plaster

Comments: This paper was found on the east wall of room 106, behind the pier mirror that hung between the windows. It was covered by two later layers of wallpaper before the pier mirror was hung. The wallpaper does not extend across the chair rail area. The border ran down the sides of the windows as well as at the cornice. The paper has horizontal seams, indicating that it was handmade. A portion of this wallpaper is still on the walls and should be conserved.

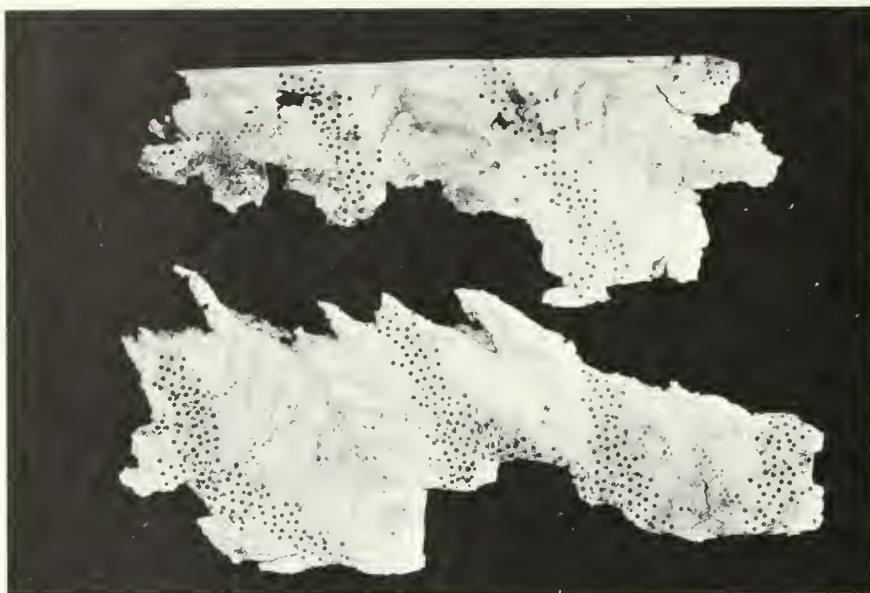
Comments: This is the second layer of wallpaper (counting up from the plaster) found under the pier mirror in room 106. It does not extend across the area from which the chair rail was removed, indicating that it predates Van Buren. Part of a strip of this wallpaper is still on the walls and should be conserved.

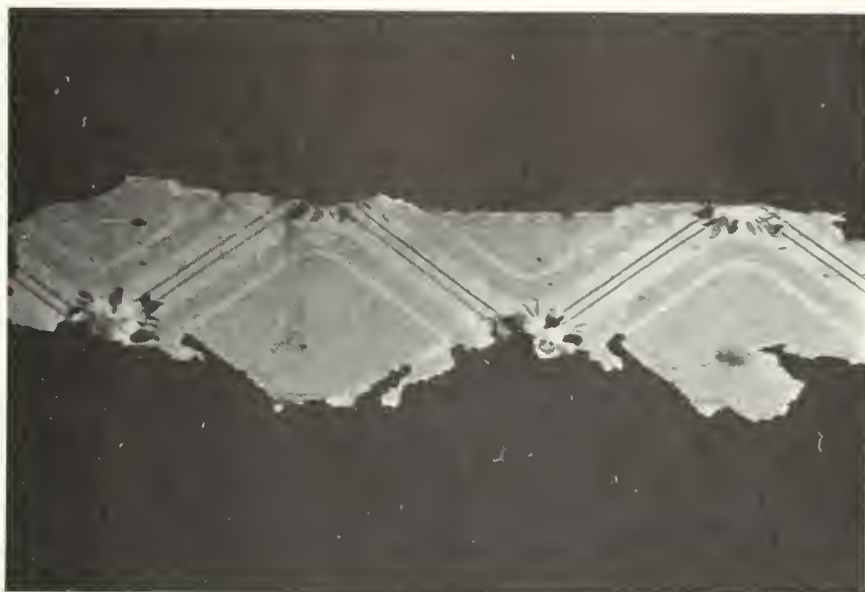
Sample No: MAVA 01 WP014
Location: Room 118 - behind
door 116 casing)
Substrate: Plaster

Comments: This wallpaper sample was found under the casing of door 116. Physical evidence found in rooms 114 and 118 indicate that this alteration was made in the latter part of the 19th century.

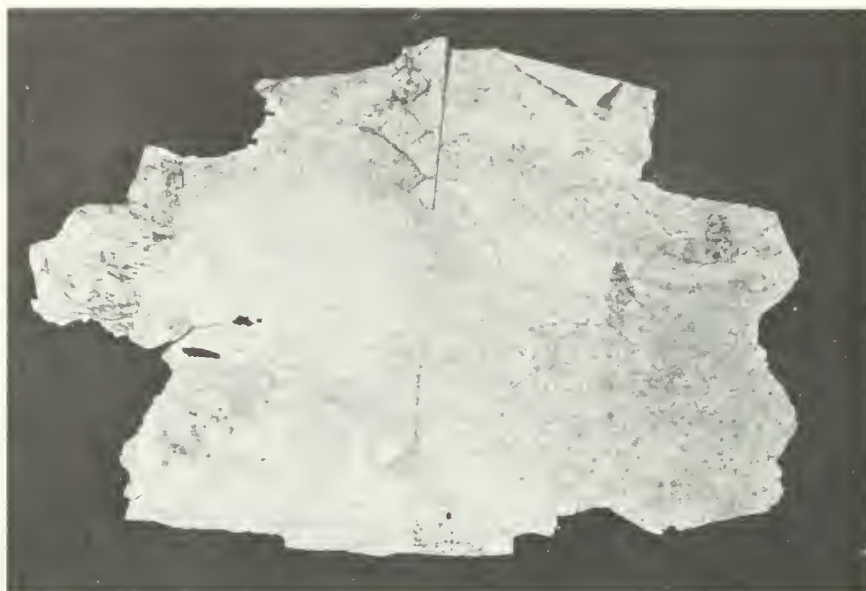
Comments: This wallpaper was found on the north wall of room 206. It has also been found in rooms 108, 207, and 208. It is the first layer of wallpaper (counting up from the plaster) in these rooms. Prior to this papering these rooms appear to have been painted. This wallpaper has been dated to Van Buren ca. 1843.

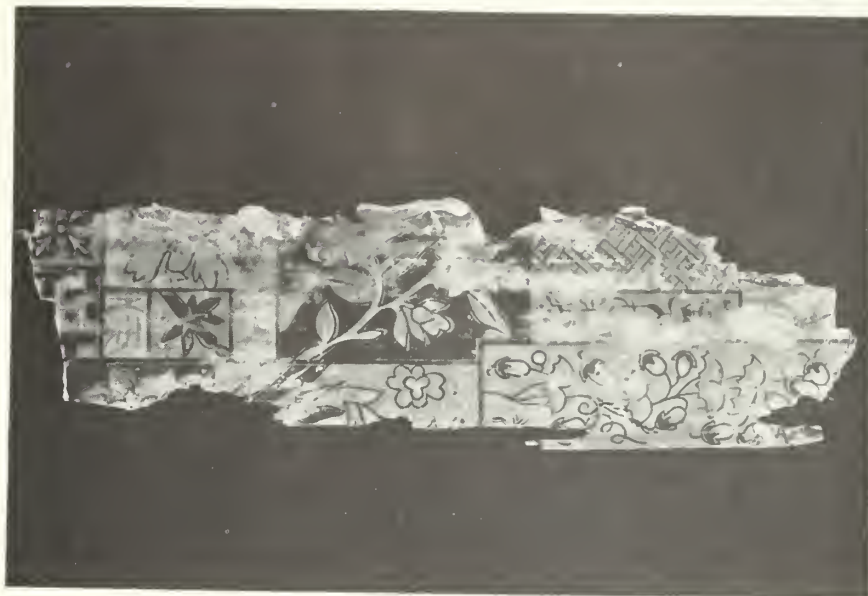
Sample No: MAVA 01 WP016
Location: Room 206 (behind
door 209 casing)
Substrate: Plaster

Comments: This wallpaper sample was taken from behind a casing near door 209 in room 206. It has also been found in rooms 108, 207, and 208. It is the second layer of wallpaper (counting from the plaster up) in these rooms.

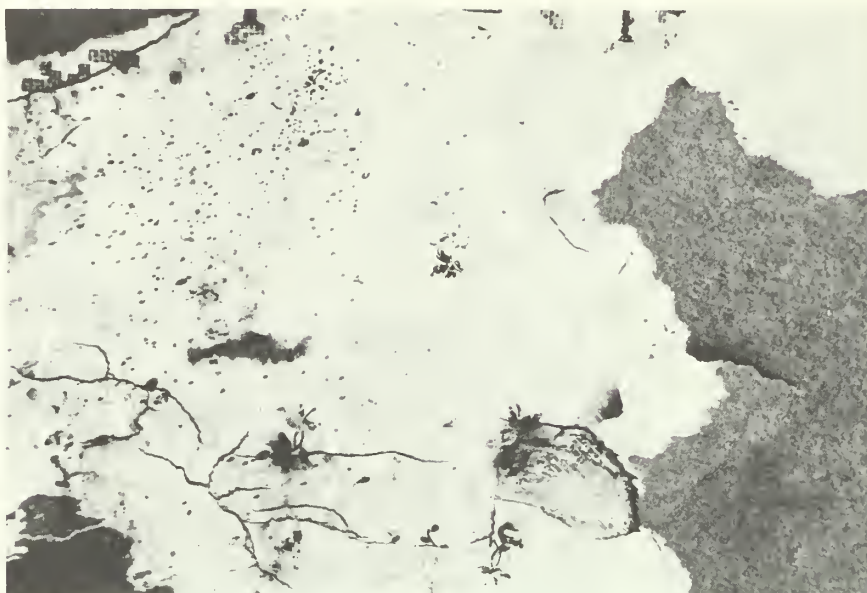
Comments: A small fragment of this wallpaper was found under the casing of the cupboard that has been built into window 212 in room 201. This sample confirmed that the wallpaper had been used on the walls as well as on the fireboard. The photo above is taken from the fireboard.

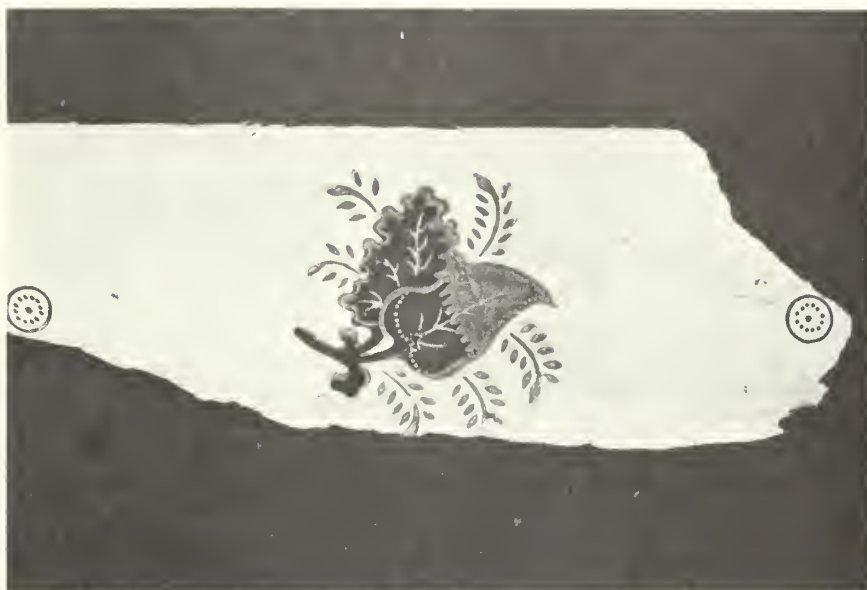
Sample No: MAVA 01 WP018
Location: Room 205 (behind
door 206 casing)
Substrate: Plaster

Comments: This sample was found behind the casing of door 206 in room 205. This door was moved roughly 2' to the north of its original location ca. 1850 (see description of room 205). A second sample of this paper was found in room 105, sandwiched between the green lining paper and the Zuber scenic. The Zuber scenic was hung in 1841.

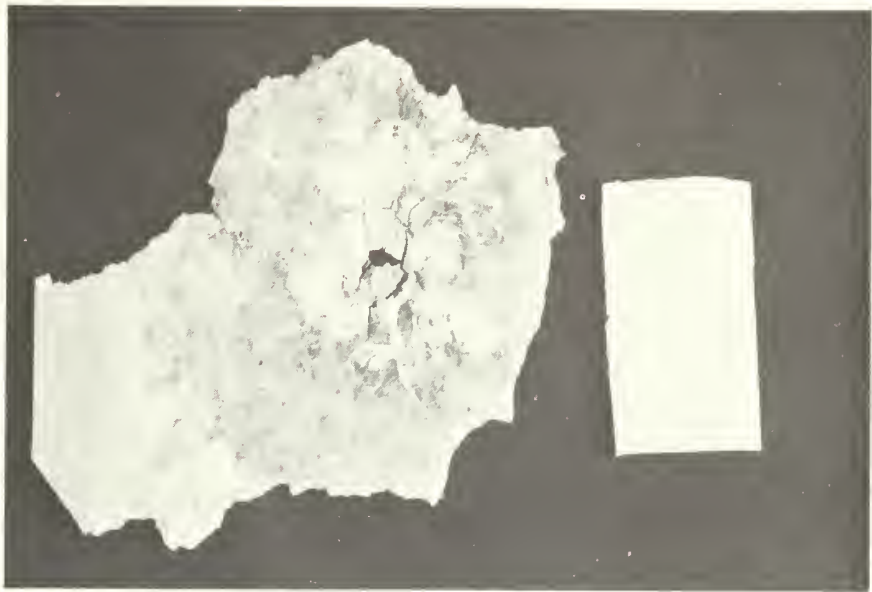
Sample No: MAVA 01 WP019
Location: Room 210 (fireboard)
Substrate: Canvas

Comments: It has been assumed that the wallpaper found on the fireboard in this room was also used on the walls, as was the case in room 201.
